Date: June 28th 2022

Location: Testing center Hoopman equipment & engineering b.v., Dinxperlosestraatweg 145, 7122 JP AALTEN (NL)

Report on testing day - the application of the Aquaholder seed coating product was carried out.

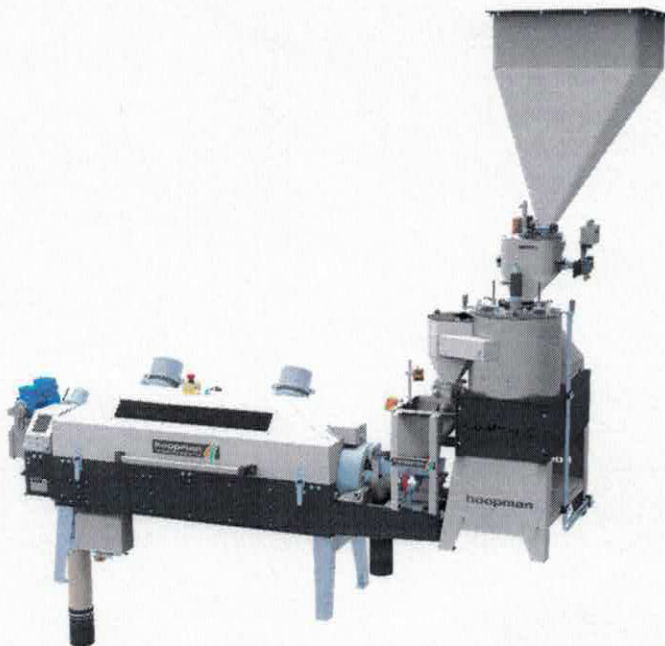
Testing took place on integrated rotary coating and drying device **IRCD350**.

- Dosage method: peristaltic pump
- Mode: variable but fully automatic/repeatable settings during first 1-24 batches.

Resulting in following 'standard application settings' but with different dryer settings (basically air temperature and air volume).

- Time of suspension dosage: 7 seconds
- Time of mixing the seed with the suspension: 10 seconds
- Drying intensity: 50%
- Drying air temperature: ranged from 25 - 38 °C
- 26 consecutive batches were performed in this mode.

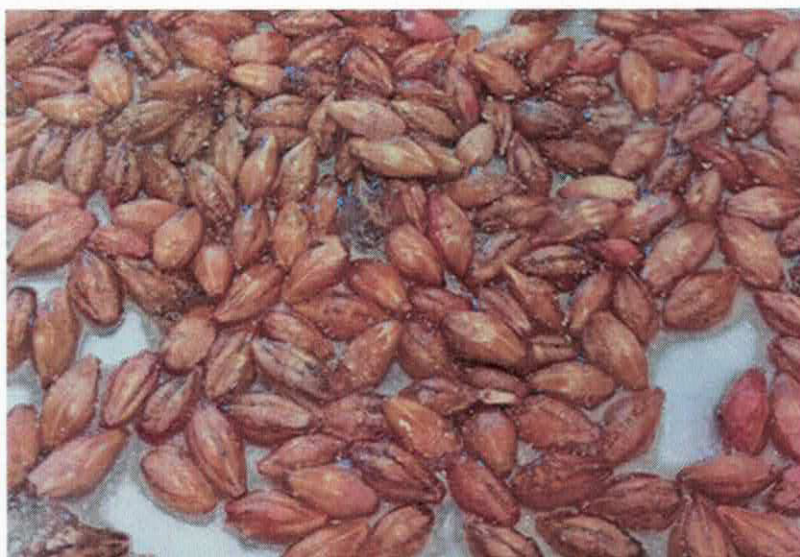
After each type of tested process, the control sample of seeds was taken, sprinkled with distilled water and the presence of the active substance was optically checked by the formation of a hydrogel around the seeds. All control samples showed the formation of a hydrogel and thus, it is possible to assume a successful binding of the active substance to the seed.
